# Manhole Inspection Summary

Manhole # S57C\_\_004MH

Insp Date: **3/4/09 1:41 PM**

**Location** Address: **4 n kresson st**

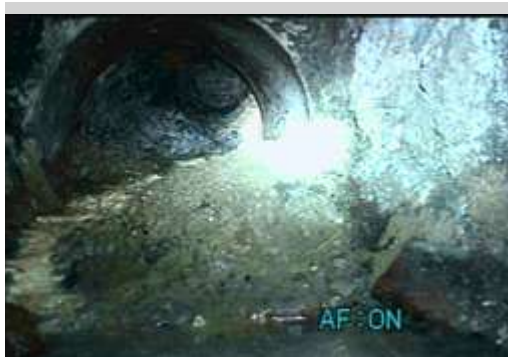
Defect 5

Condition: ☐ Sound ☐ Cracked ☐ Root Intrusion ☐ Deteriorated ☐ Leaks ☒ **Debris**

channel debris

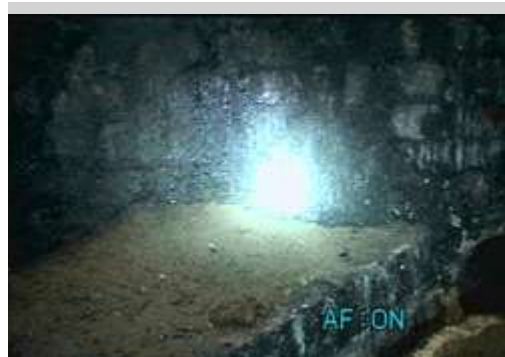
Defect 4

Condition: ☐ Sound ☐ Cracked ☐ Root Intrusion ☐ Deteriorated ☐ Leaks ☒ **Debris**

bench debris

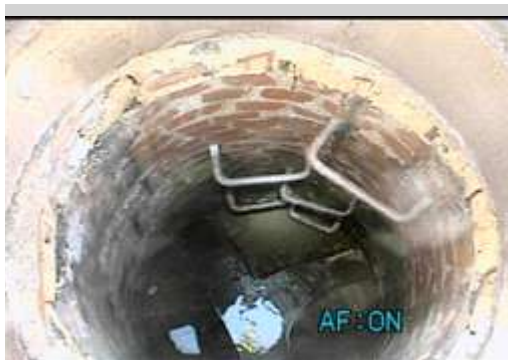
Defect 3

Count: **5** Missing: **0** ☒ **Corroded**

corr steps

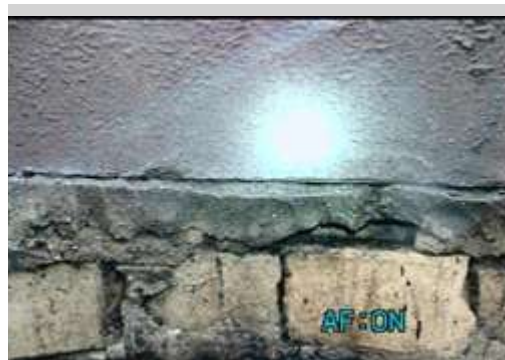
Defect 2

Condition: ☐ Sound ☐ Cracked ☐ Root Intrusion ☐ Loose Brick ☒ **Deteriorated**

chimney deteriorated

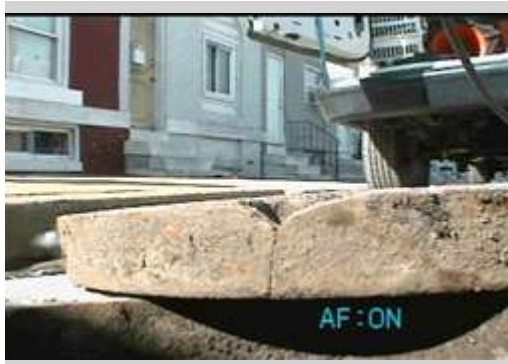
### Defect 1

Condition: **Cracked**

cracked cover

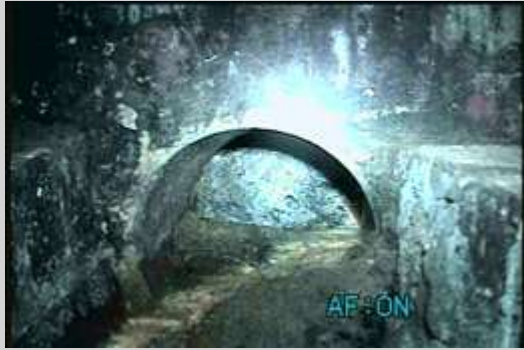
9 O'Clock Inflow

appears to be abandoned
